TECHNICAL REPORT ARLCD-TR-78021

DETERMINATION OF MINIMUM NON-PROPAGATION
DISTANCE OF 81-MM M374A1 PROJECTILES

DOUGLAS KOGER
WILLIAM STIRRAT

US ARMY ARMAMENT RESEARCH AND DEVELOPMENT COMMAND
LARGE CALIBER
WEAPON SYSTEMS LABORATORY
DOVER, NEW JERSEY

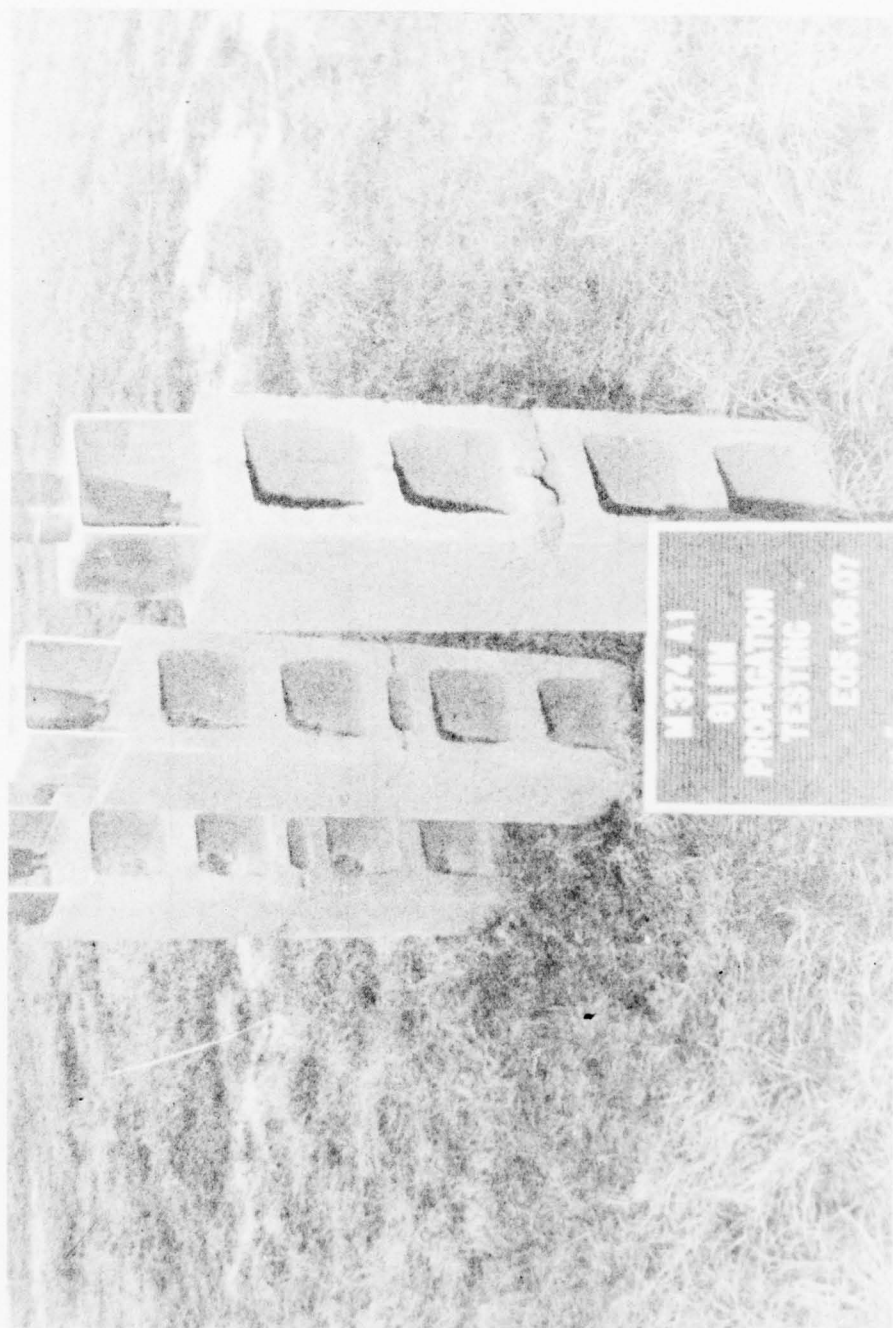
Fig 4 Single projectile safe separation distance
test set-up prior to ignition

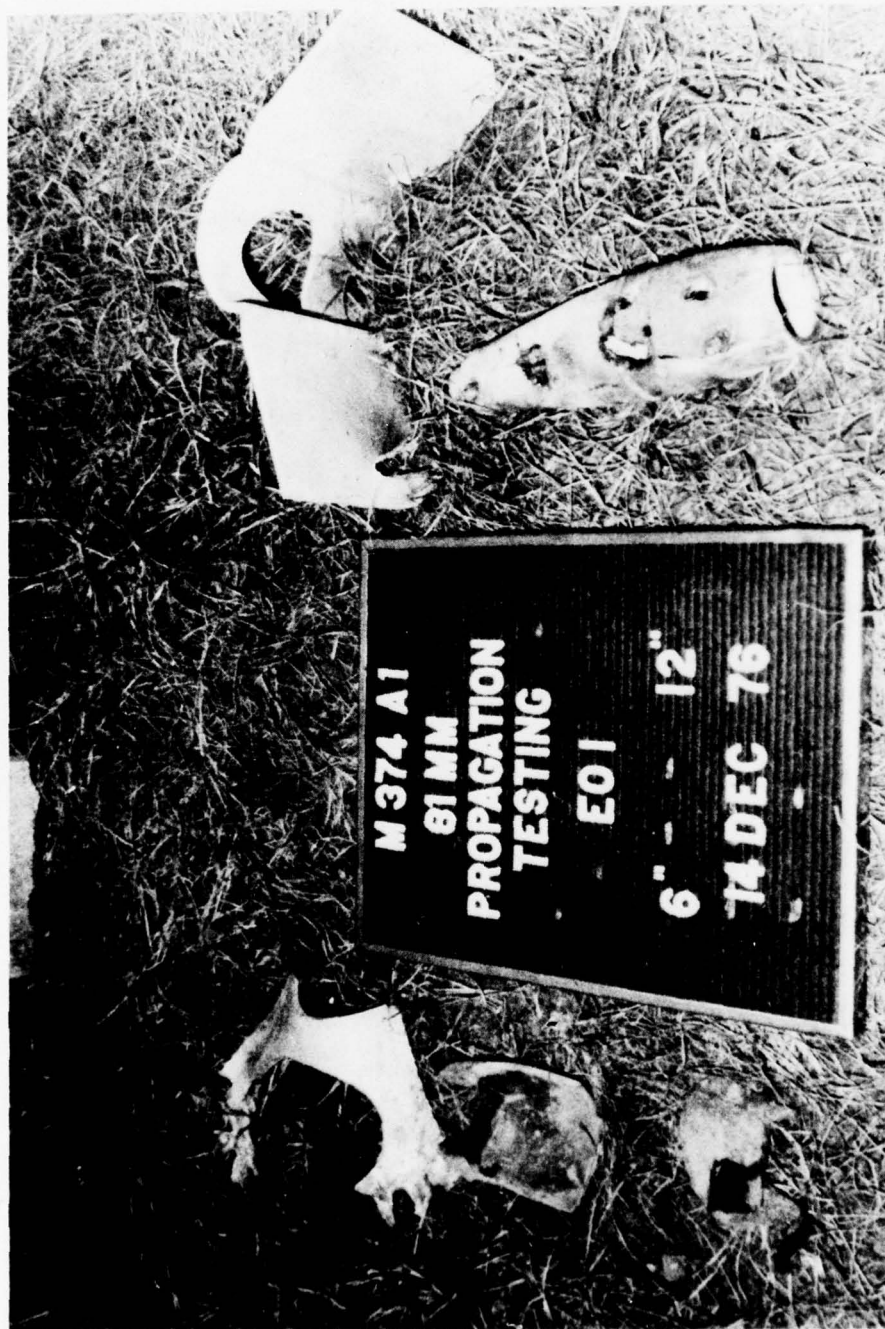
Fig 8 Single projectile post test results showing typical acceptors at 6-inch and 12-inch safe separation distances

Ten single projectile exploratory tests (E01 - E10) were conducted with the results as shown in Table 2. Table 1 presents a more definitive description of terms used in the "remarks" section of Tables 2 through 6. Separation distances ranged from 15.24 centimeters (6 inches) to 60.96 centimeters (24 inches). In only one case, the 15.24-centimeter (6-inch) distance, was there an indication of a detonation propagation to reaction. This was not wholly confirmed, but was surmised due to the absence of the aft section of the projectile; i.e., no major fragments from this section were found. The remainder of the case was ruptured as shown in Figure 8.

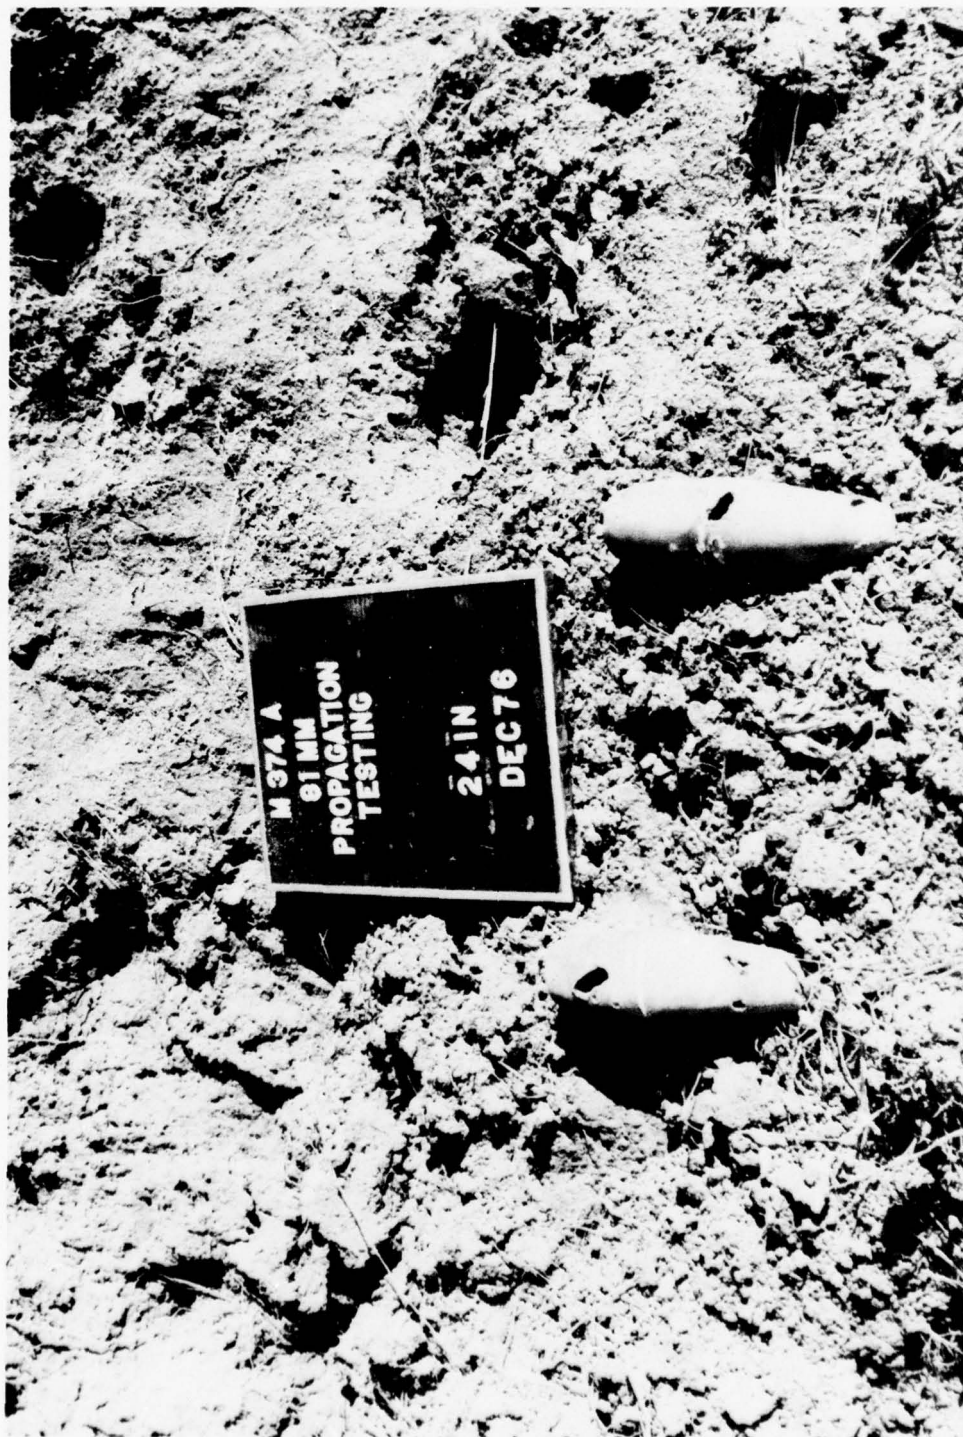
Fig 9 Single projectile post-test results showing typical acceptors at the 24-inch safe separation distance

interest is the fact that there were no detonation propagation reactions in any of the 34 acceptors. These results, added to the 19 acceptors from the exploratory phase, give a statistical population of 53 single acceptor projectiles which did not propagate to detonation at safe separation distances less than or equal to 60.96 centimeters (24 inches). All but one of the 34 acceptors at 60.96 centimeters (24 inches) were penetrated by fragments. In three cases, the Composition B was entirely burned; in four cases, only slight (less than 5 percent) burning resulted. Figure 9 shows typical fragment penetration results at this distance.

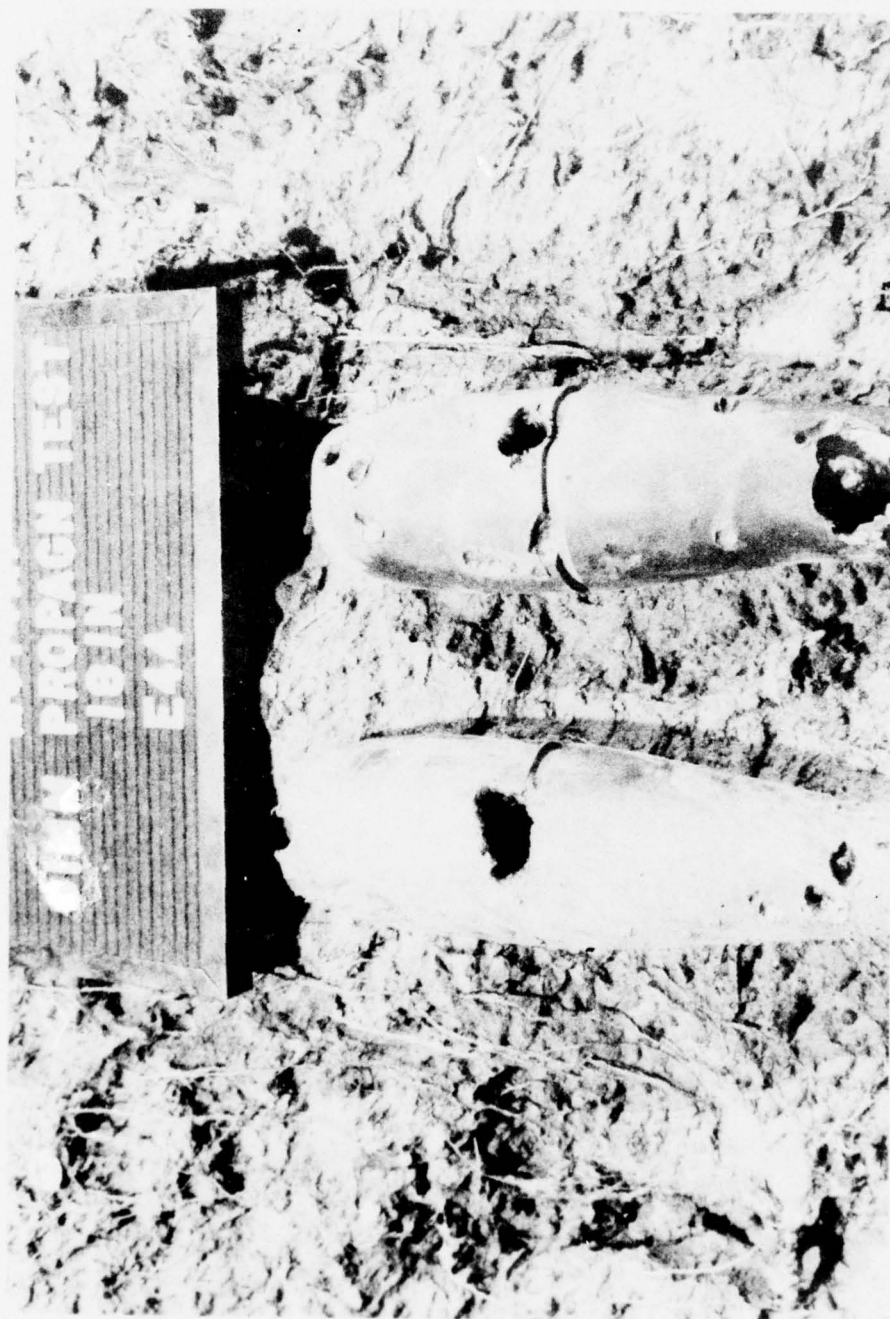
Fig 10 Single projectile post-test results showing typical fragment penetrations and case damage (Test No. E44)

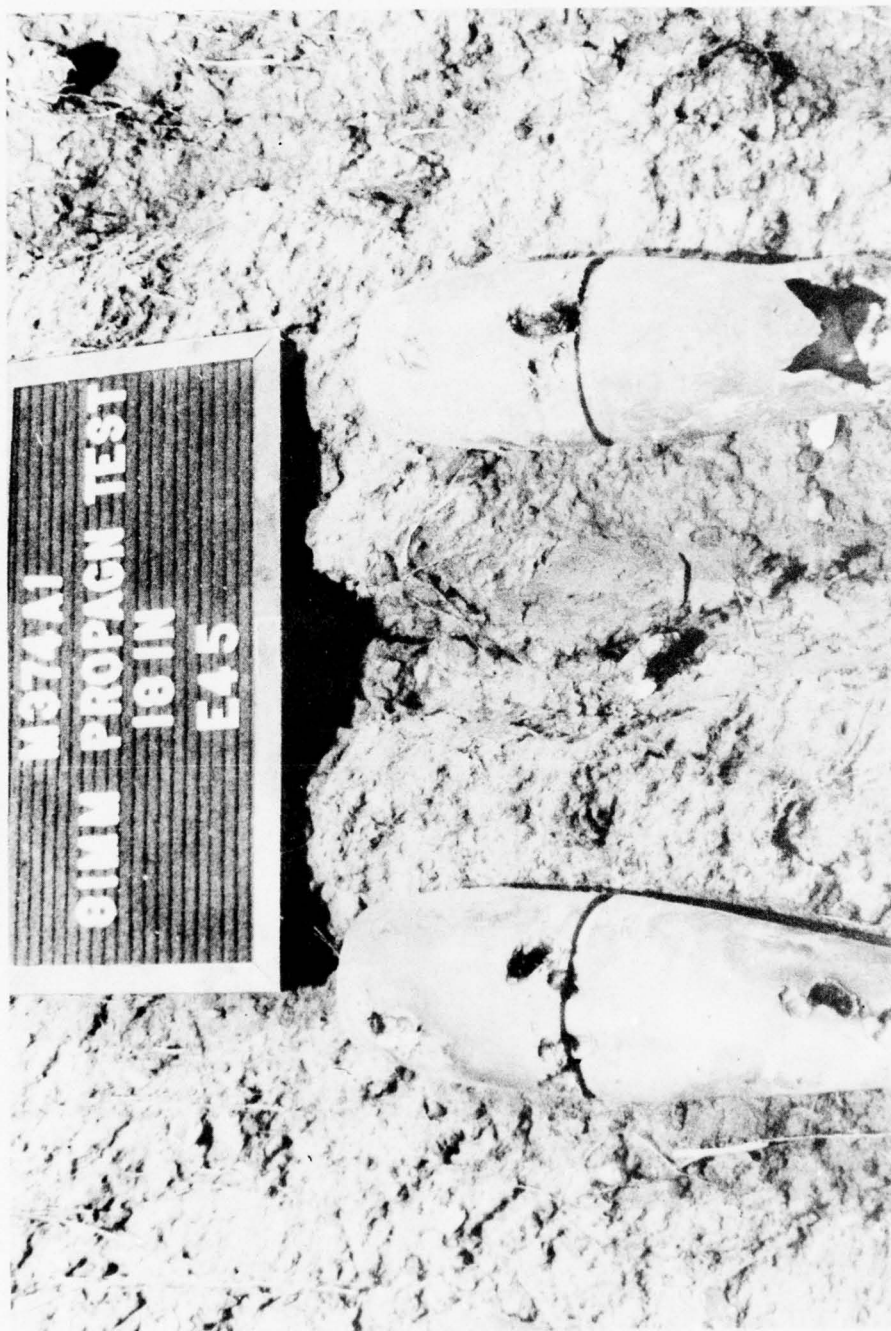
Fig 11 Single projectile post-test results showing typical fragment penetrations and case damage (Test No. E45)

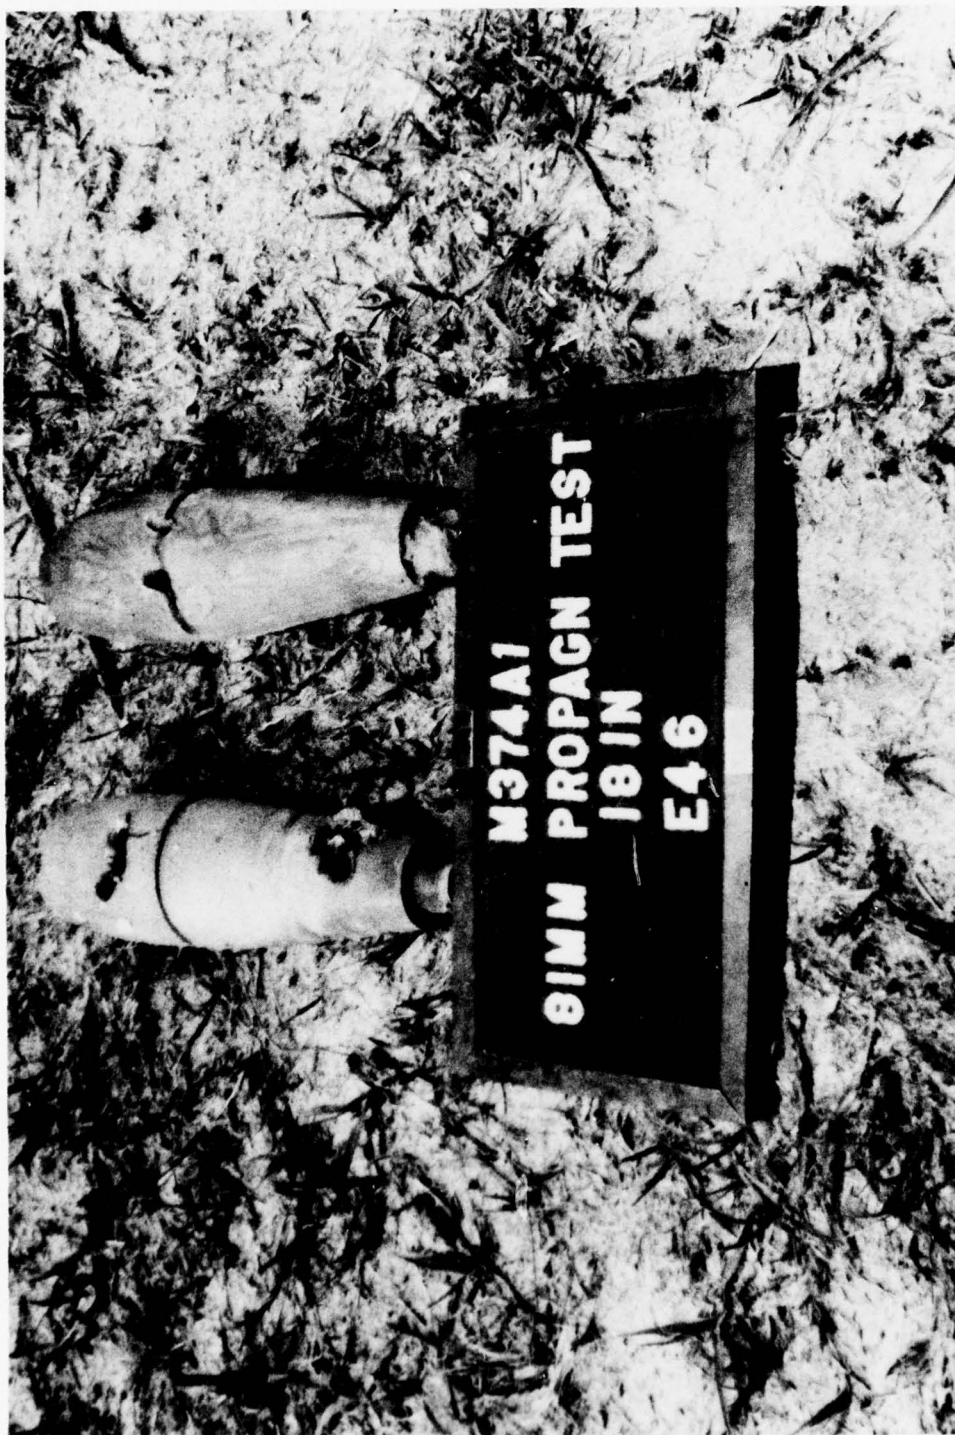
Fig 12 Single projectile post-test results showing typical fragment penetrations and case damage (Test No. E46)

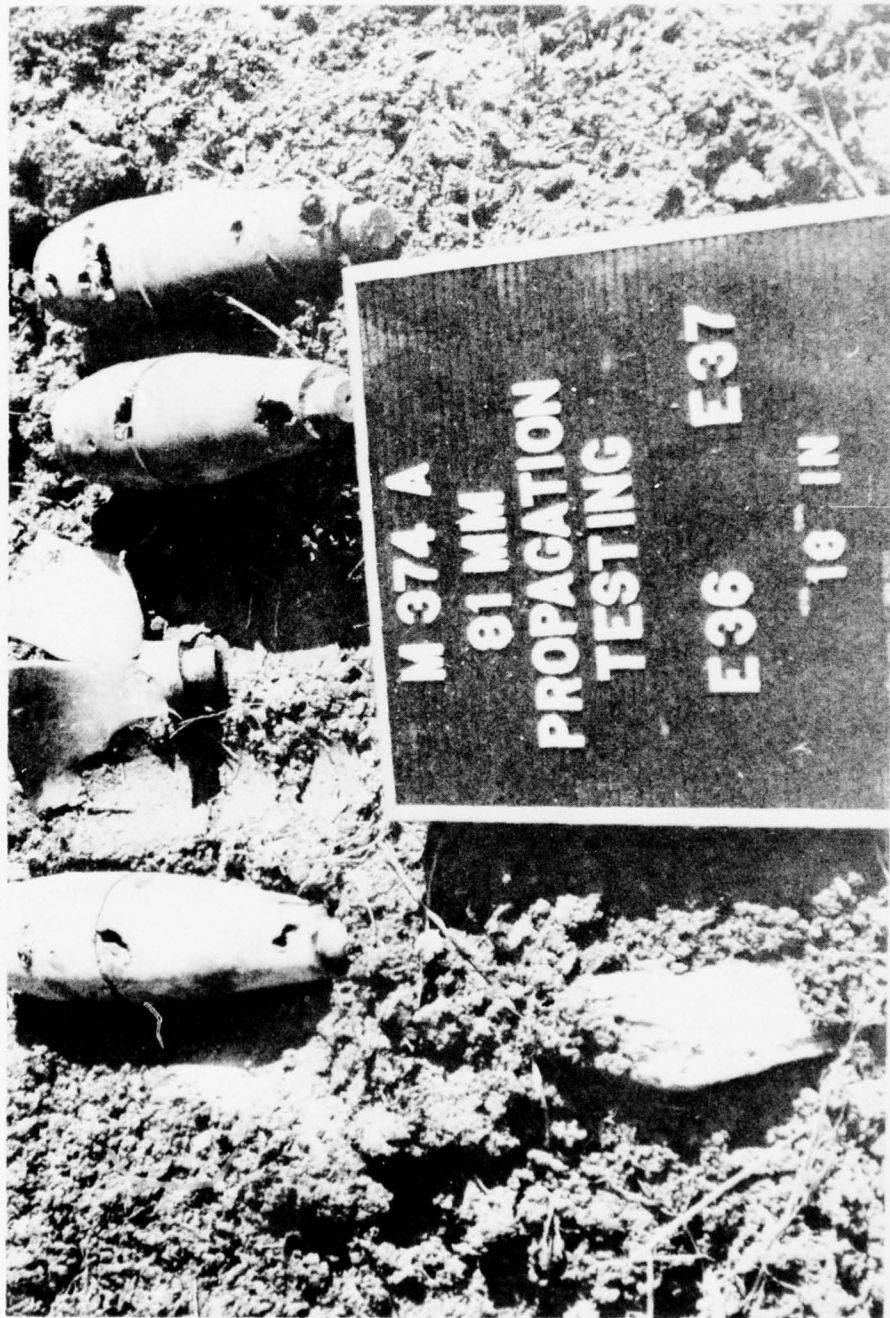
Fig 13 Single projectile post-test results showing typical fragment penetrations and a pneumatically ruptured case from Test E36

An additional 26 tests (52 acceptors), E28 - E53, were conducted at the 45.72-centimeter (18-inch) separation distance. The results of these tests are summarized in Table 4. Of significance regarding this data is that there were no propagation to detonation reactions in any of the 52 acceptors analyzed, although 50 of the acceptors were penetrated by fragments as described in the "remarks" columns of the table. Figures 10 and 11 show typical acceptor projectiles from this test series. The Composition B in slightly less than 10 percent of the rounds (5 of 52) was totally burned; in one case, approximately 60 percent of the explosive burned and in nine cases, only slight (less than 5 percent) burning resulted. Seven rounds suffered severe damage to the extent that they were cracked open, or pneumatically ruptured. In all of these cases there was sufficient physical evidence in the form of large case segments and unburned Composition B remaining to support the conclusion that no detonations had occurred. Figures 12, 13, 14 and 15 show additional typical acceptor projectiles from this test series.

| OBSERVED RESULTS | | | | | | |
|---|---|---|---|---|---|---|
| E36 | 6.1 (20) | 0 | Three 6.35-mm (1/4") diameter perforations | 24.38 (80) 45.72 (150) | UNK** | Large piece found 24.38 m (80') from ground zero; small piece found approximately 45.70 m (150') away. Pneumatic rupture of case, no evidence of detonation or burning. Remainder of case never found. Large piece of Comp B found in ditch to south (200 feet away). |

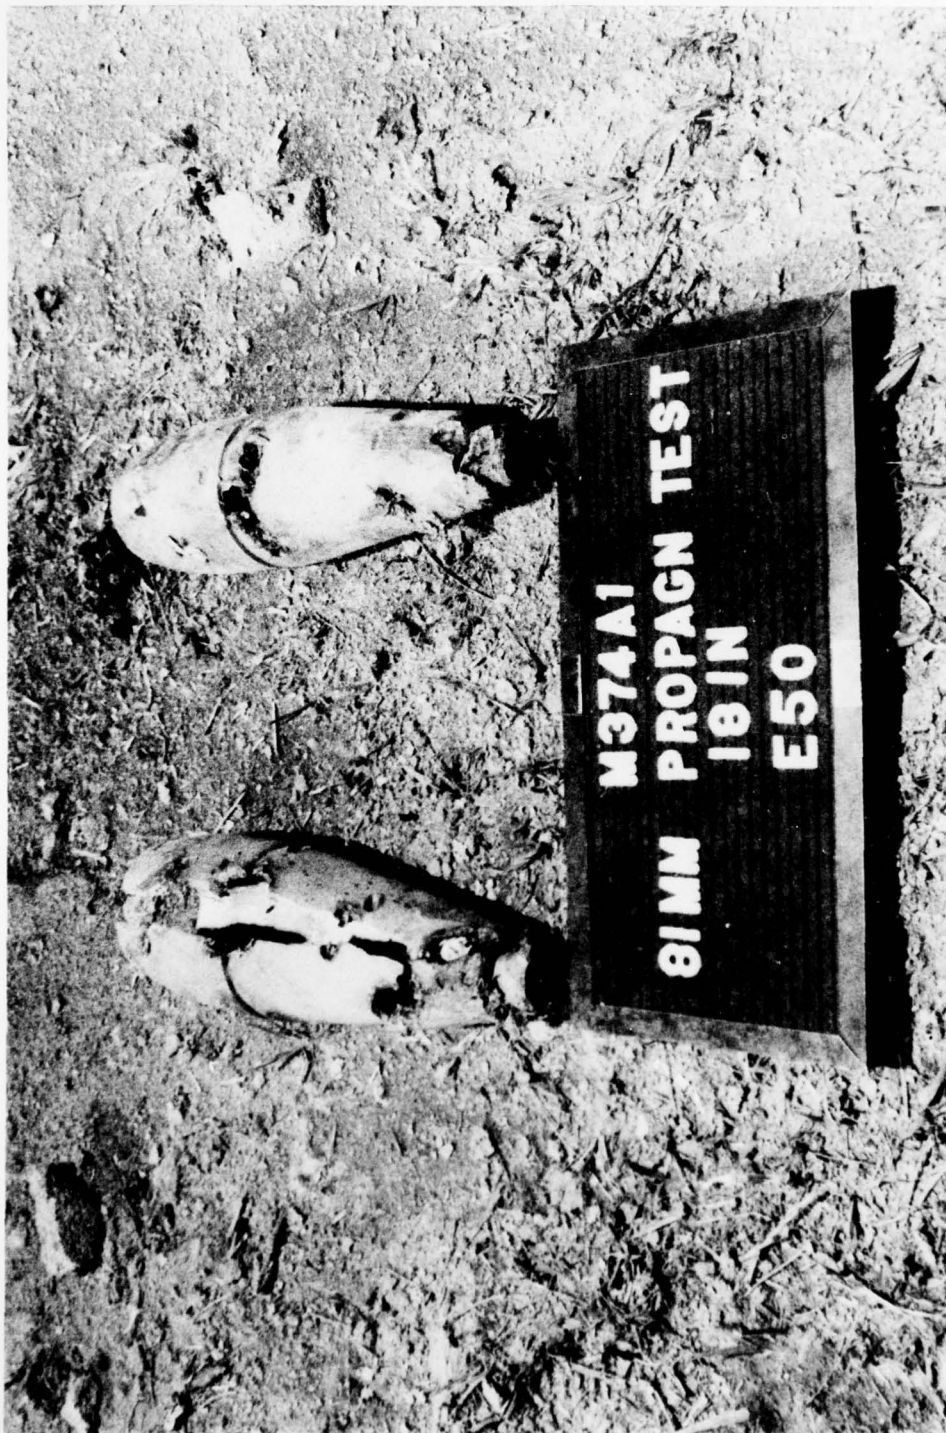
Fig 14 Single projectile post-test results showing typical fragment penetrations and an acceptor projectile (on right with 60% of Composition B burned)

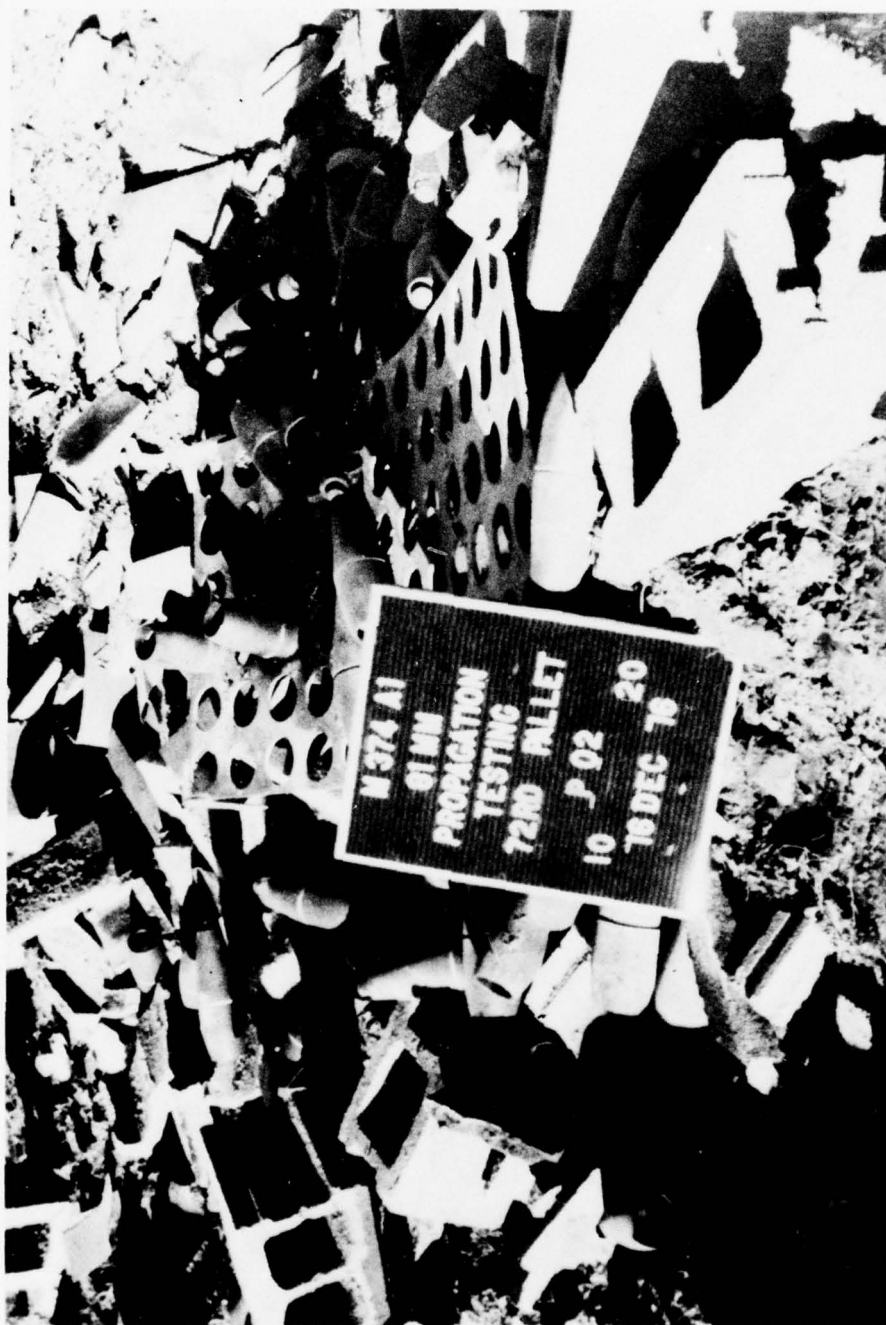
Fig 16 72-projectile acceptor pallet after test at 3.05-meter
(10-foot) separation distance - propagation did not occur

between donor and acceptors ranged from 1.52 meters (5 feet) to 12.19 meters (40 feet), and only the 1.52-meter (5-foot) distance (Test P04) resulted in a propagation to detonation reaction. In this case, immediate detonation of all 72 projectiles in the acceptor pallet was observed. The acceptor at 3.04 meters (10 feet) (Test P02) resulted in a fire in one of the rounds; this round pneumatically ruptured. The pneumatic rupture conclusion was based on the muffled, low-order sound of the reaction, the large fragments recovered, the appearance of the fracture, the presence of unconsumed Composition B and the relatively undisturbed area where the round reacted. The seven acceptor pallets at 6.1 meters (20 feet) exhibited relatively little damage in terms of projectiles penetrated by fragments. One projectile burned 100 percent on the acceptor pallet in Test P05. The acceptor at 12.19 meters (40 feet) (Test P01) had only one projectile penetrated. Figures 16, 17 and 18 show typical results of this series.

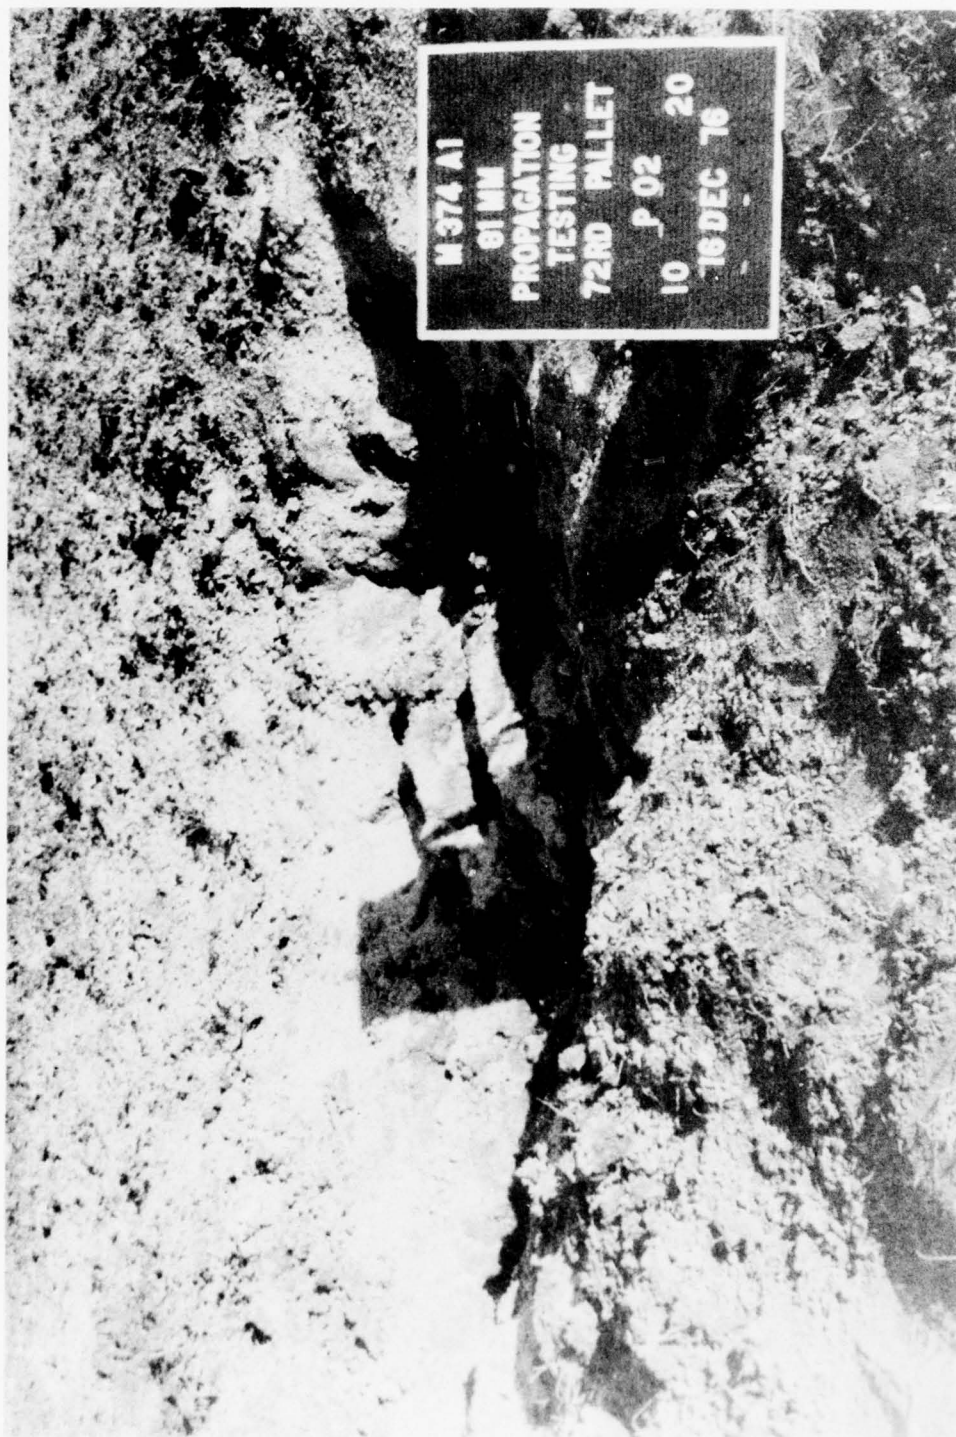
Fig 17 Typical donor crater after simultaneous detonation of 72 rounds

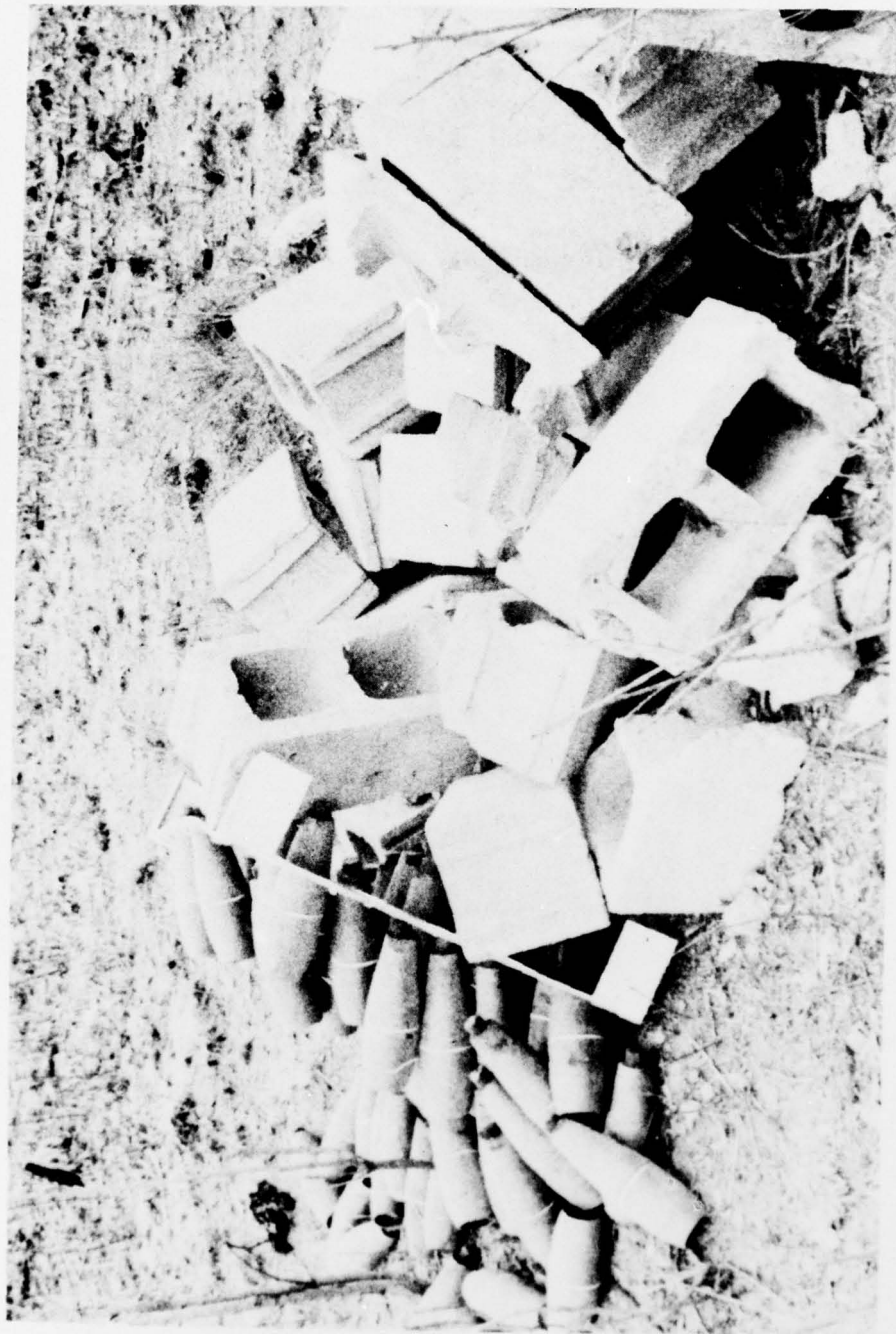
Fig 18 Typical 72-projectile acceptor pallet at the 9.14-meter
(30-foot) safe separation distance after test
